**COMPREHENSIVE MOTOR VEHICLE SERVICES AND
CONSULTING
MOTOR VEHICLE FORENSIC ANALYSIS
REPORT**

CMVSC-18-IA-245

-- In the Matter of the Death of Edson Thevenin --

INVOLVED DYNAMIC SUBJECT VEHICLE: 2000 Honda Civic EX Two Door Coupe

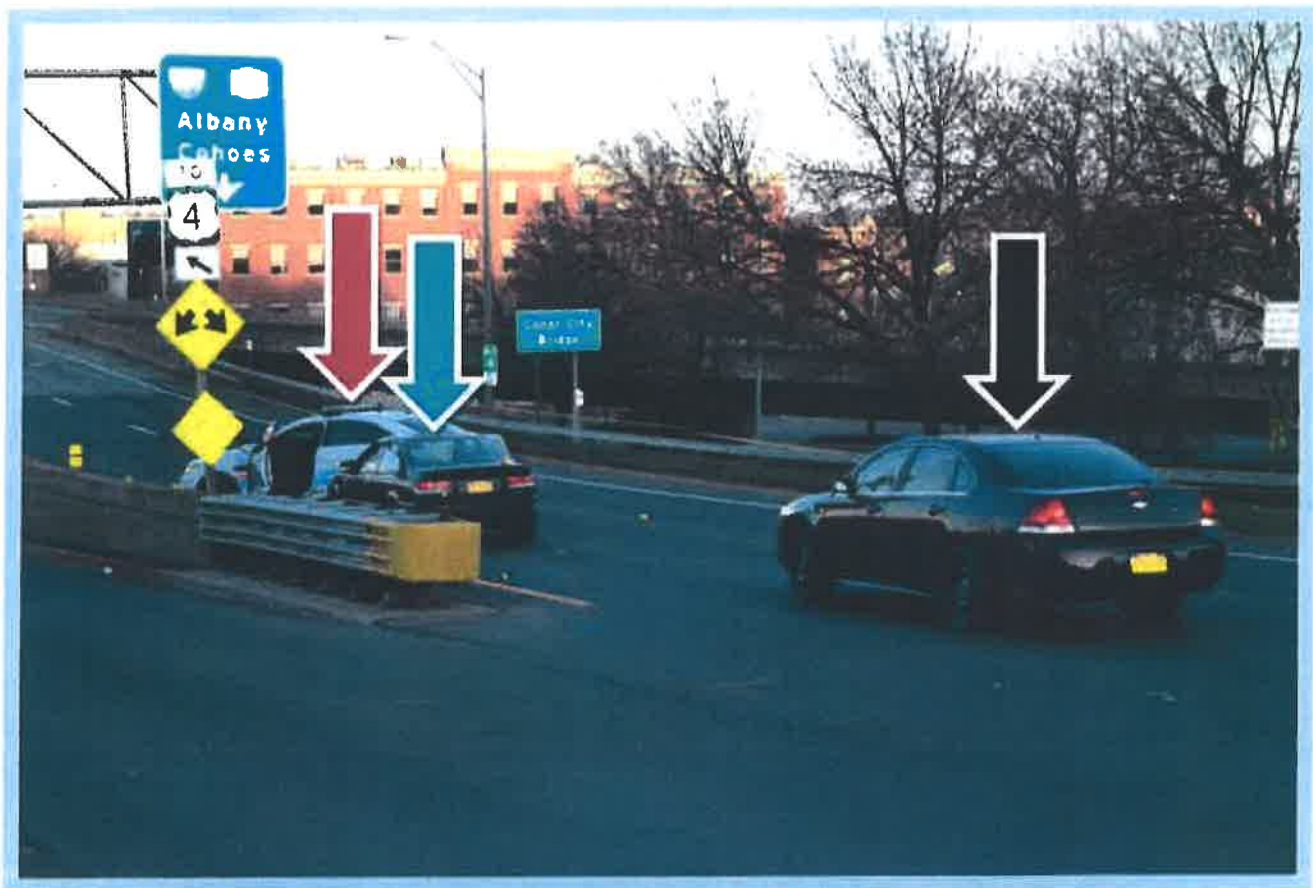
Image No. 1 This photograph, courtesy of the Troy (New York) Police Department, depicts the scene of final rest of the three involved vehicles with respect to the events of April 17, 2016. The Red Arrow denotes the 2013 Ford Taurus police cruiser operated by Troy Police Sergeant Randall French. The Blue Arrow denotes the 2000 Honda Civic operated by Edson Thevenin. The Black Arrow denotes the 2013 Chevrolet Impala police vehicle operated by Troy Police Captain Matthew Montanino, which had been moved rearward from its actual final rest location.

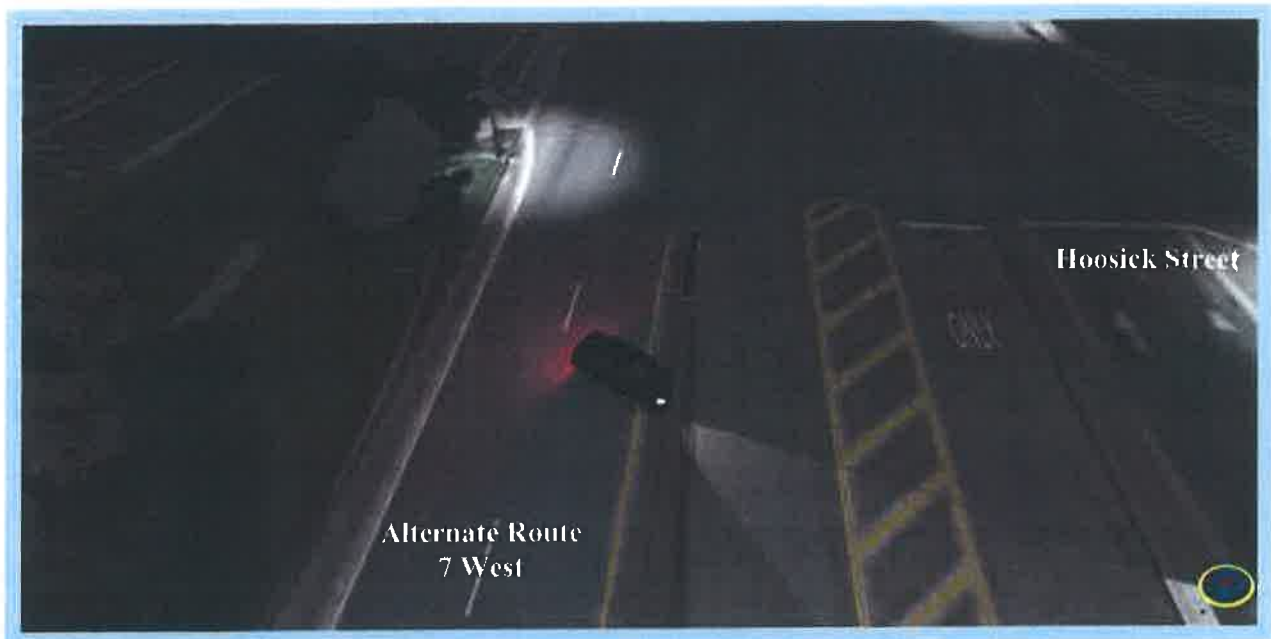
The impact of the westbound 2000 Honda Civic into the concrete median barrier system occurred at an approximate angle of 118 degrees, as determined by and through digital tram assessment of the sustained contact and structural damage at the left front section of the Honda Civic.³

Image No. 4. This 3D Forensic Animation Still Image depicts the approximate initial concrete barrier impact location of the 2000 Honda Civic operated by Edson Thevenot while in a westerly direction on Alternate Route 7 (Collar City Bridge) after negotiating a left turn from Hoosick Street. This computer generated image was created by utilizing forensic scene mapping data, scene photographs, involved vehicle photographs, and forensic damage analyses of the involved 2000 Honda Civic.

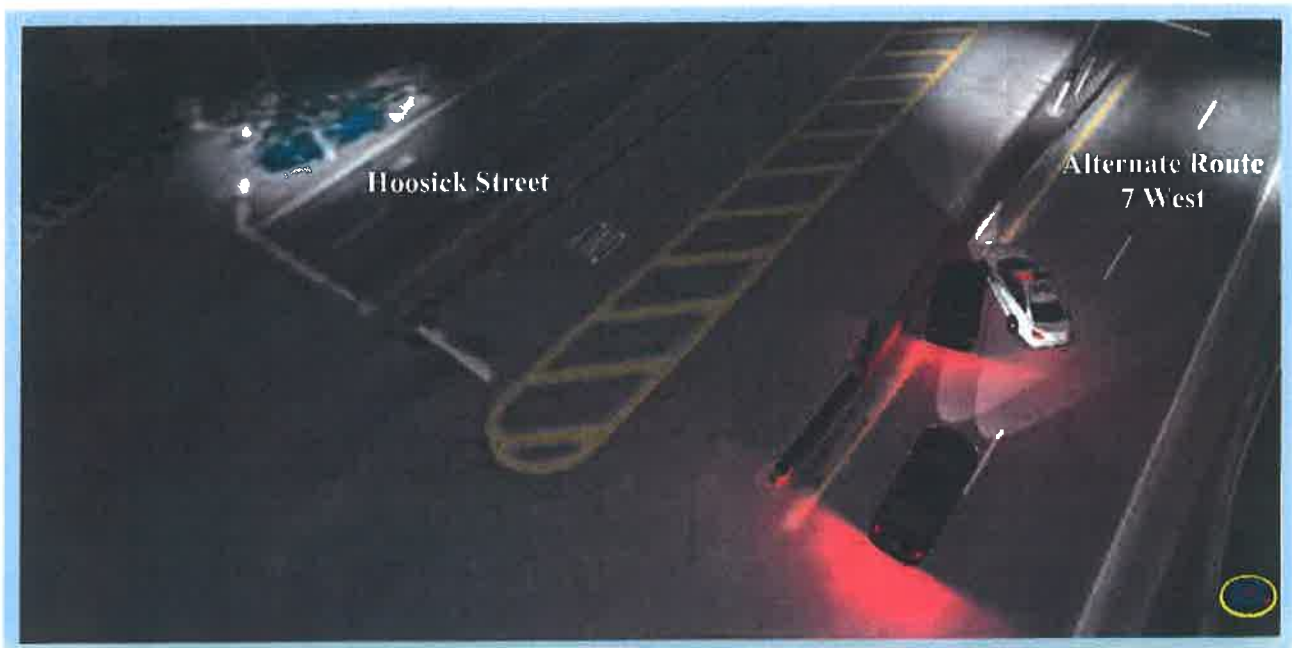
Due to the intensity of the impact of the 2000 Honda Civic operated by Edson Thevenin with the concrete barrier, as well as the approximate 118 degree angle of impact, the left frontal area of the vehicle was propelled into a forced westerly concrete barrier slide of approximately fifty-one (51) inches. This clockwise rotation of the 2000 Honda was substantiated by 1) concrete barrier evidence; 2) roadway right front Honda tire scuff mark; and 3) Honda physical crash evidence. (Also see Image No. 46, Page 61.)

Image No. 5. This 3D Forensic Animation Still Image depicts the approximate final concrete barrier impact location of the 2000 Honda Civic operated by Edson Thevenin subsequent to clockwise rotation of the vehicle due to the severity of the impact and angle of approach while in a westerly direction on Alternate Route 7 (Collar City Bridge) after negotiating a u-turn from Hoosick Street. This computer generated image was created by utilizing forensic scene mapping data, scene photographs, involved vehicle photographs, and forensic damage analysis of the involved 2000 Honda Civic.

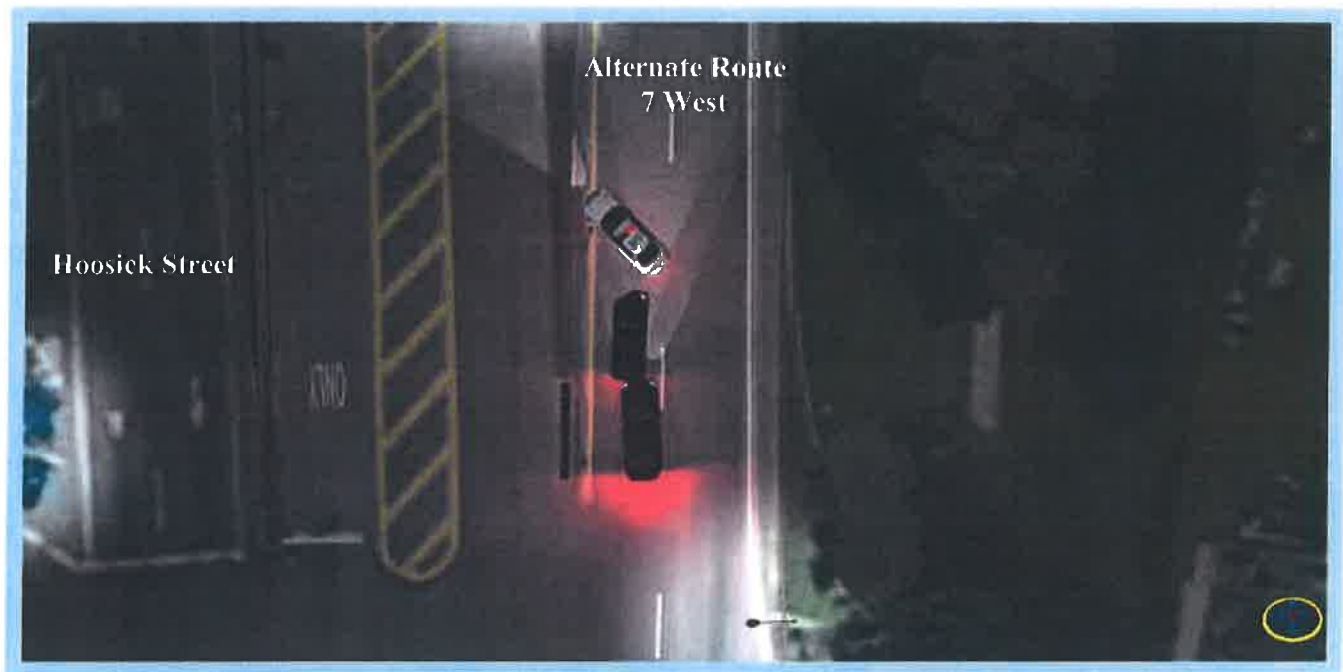
Image No. 6: This 3D Forensic Animation Still Image depicts the approximate location of the 2000 Honda Civic operated by Edson Thevenin at impact with the Troy Police Department 2012 Chevrolet Impala after backing from concrete barrier final impact location on Alternate Route 7 (Collins City Bridge). This computer generated image was created by utilizing forensic scene mapping data, scene photographs, involved vehicle photographs, and forensic damage analyses of the involved 2000 Honda Civic and 2012 Chevrolet Impala.

Of note is the distance of approximately thirty-nine (39) inches between the right front bumper of the 2000 Honda Civic and the left rear wheel area of the marked Troy Police Department 2013 Ford Taurus operated by Troy Police Sergeant Randall French.

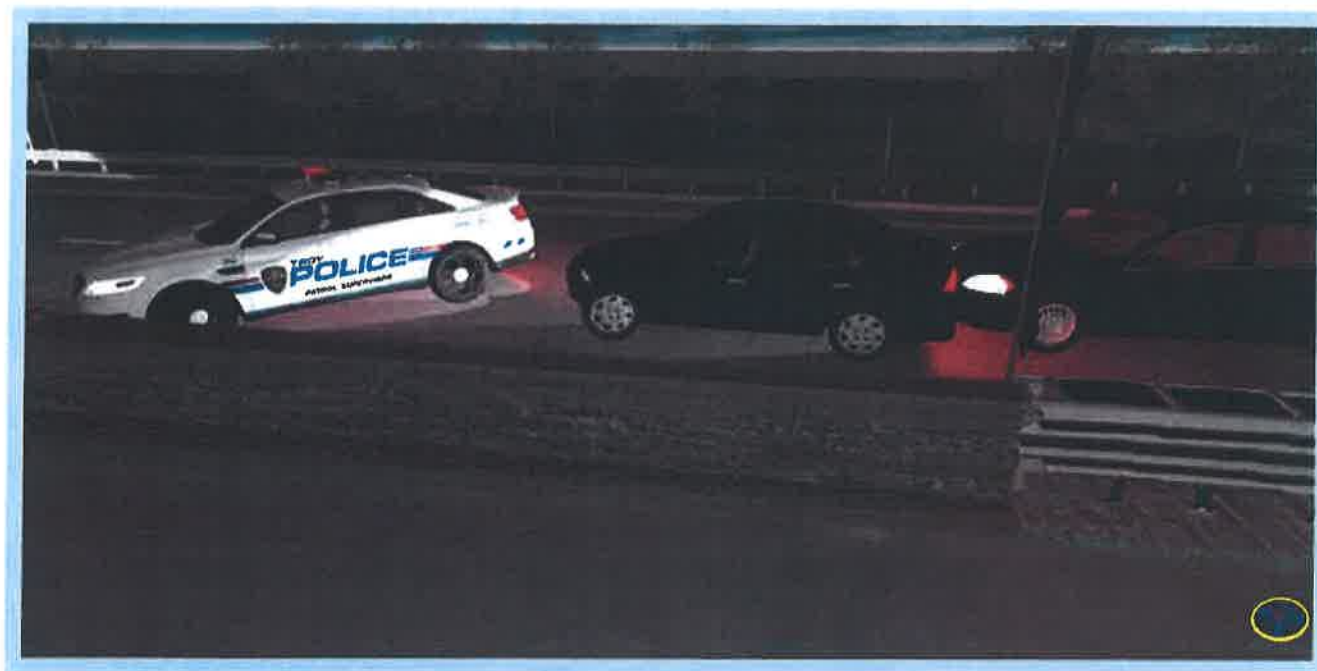
Image No. 6h. This 3D Forensic Animation Still Image depicts the Hoosack Street view of the approximate location of the 2000 Honda Civic operated by Edson Thevenin at impact with the Troy Police Department 2012 Chevrolet Impala after backing from concrete barrier final impact location on Alternate Route 7 (Collar City Bridge). This computer generated image was created by utilizing forensic scene mapping data, scene photographs, involved vehicle photographs, and forensic damage analyses of the involved 2000 Honda Civic and 2012 Chevrolet Impala.

Of note is the distance of approximately thirty-nine (39) inches between the right front bumper of the 2000 Honda Civic and the left rear wheel area of the marked Troy Police Department 2013 Ford Taurus operated by Troy Police Sergeant Randall French.

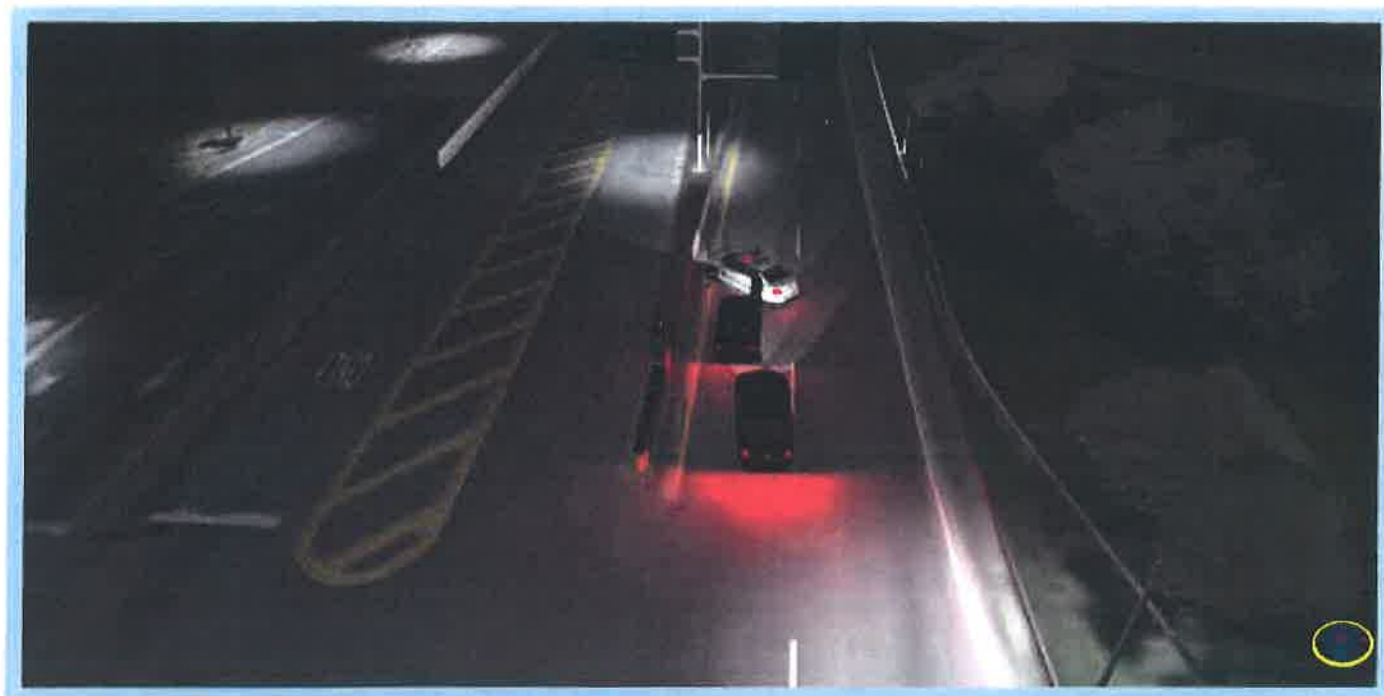
approximately thirty-nine (39) inches to impact with Troy Police Sergeant Randall French, who had exited the driver seat and was positioned in the proximity of the left rear quarter panel of the marked Troy Police Department 2013 Ford Taurus.

Image No. 7a. This 3D Forensic Animation Still Image depicts the approximate location of the 2000 Honda Civic operated by Edson Thivernin at impact with Troy Police Sergeant Randall French at the left rear quarter panel area of the Troy Police Department 2013 Ford Taurus after having been accelerated a distance of approximately 39 inches in a forward trajectory from the area of previous impact with the Troy Police Department 2012 Chevrolet Impala. This image is that of facing westerly on Alternate Route 7 (Collins City Bridge). This computer generated image was created by utilizing forensic scene mapping data, scene photographs, involved vehicle photographs, and forensic damage analyses of the involved 2000 Honda Civic.

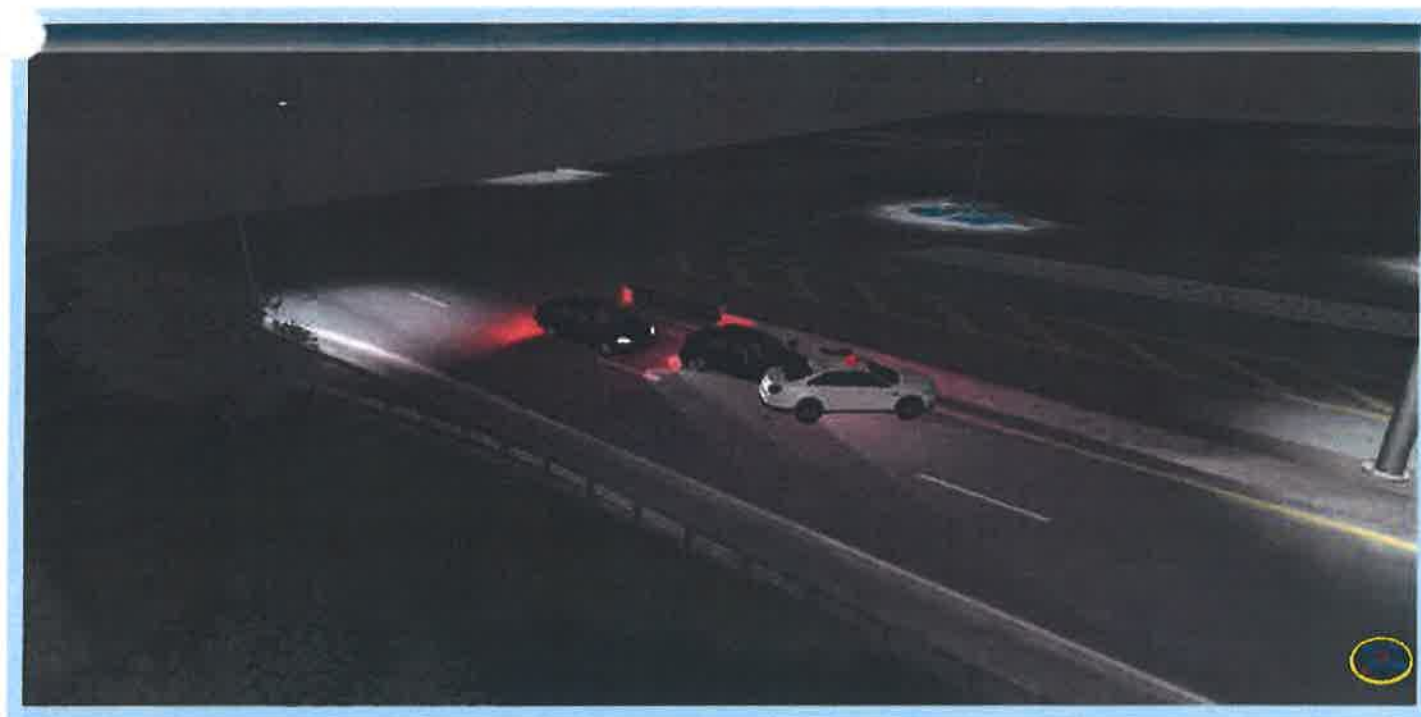
Image No. 7h This 3D Forensic Animation Still Image depicts the approximate location of the 2000 Honda Civic operated by Edison Thevenin at impact with Troy Police Sergeant Randall French at the left rear quarter panel area of the Troy Police Department 2013 Ford Taurus after having been accelerated a distance of approximately 39 inches in a forward trajectory from the area of previous impact with the Troy Police Department 2012 Chevrolet Impala. This image is that of viewing the scene in a southerly direction.

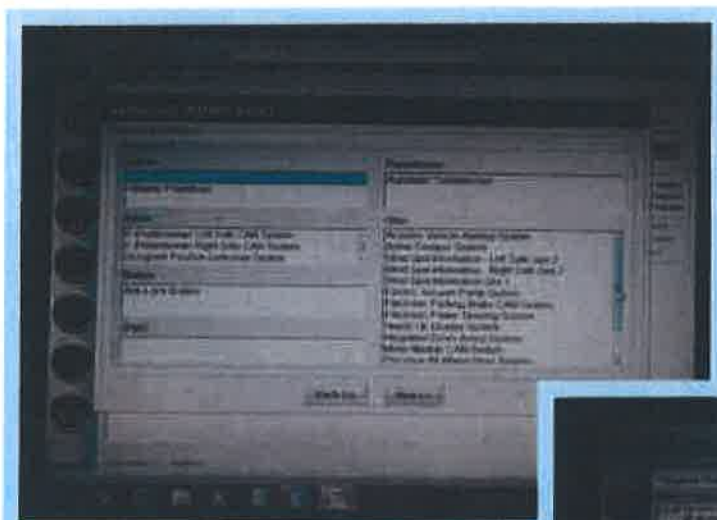
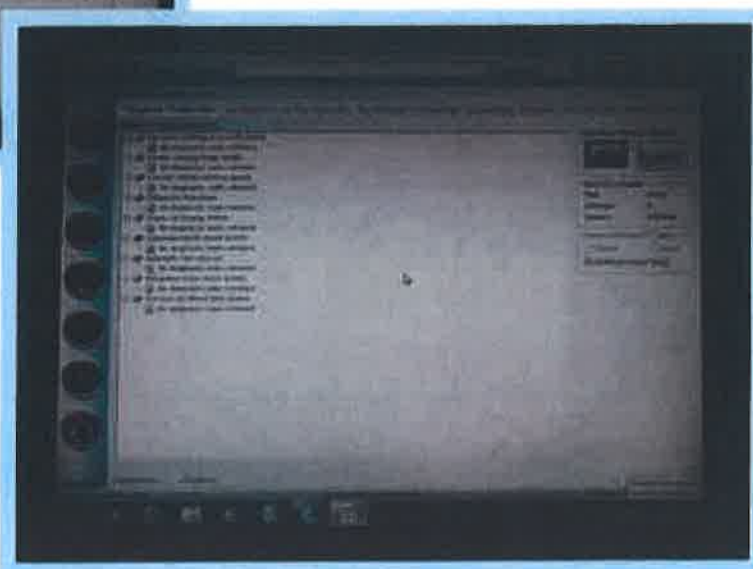
The 2000 Honda Civic EX which is the subject of these forensic analyses was manufactured with numerous computer control systems. As a procedure of the forensic vehicle analyses in this matter, computer serial data communications were initiated to provide both real time and history overview data of the computer control systems. This analysis revealed no faults within any of the computer controlled systems of the vehicle. Mode 02 Data was not recorded at impact.

Images No. 19a & 19b These photographs depict screenshot images of computer serial data communications with the computer control modules of the 2000 Honda Civic. There were no system faults.

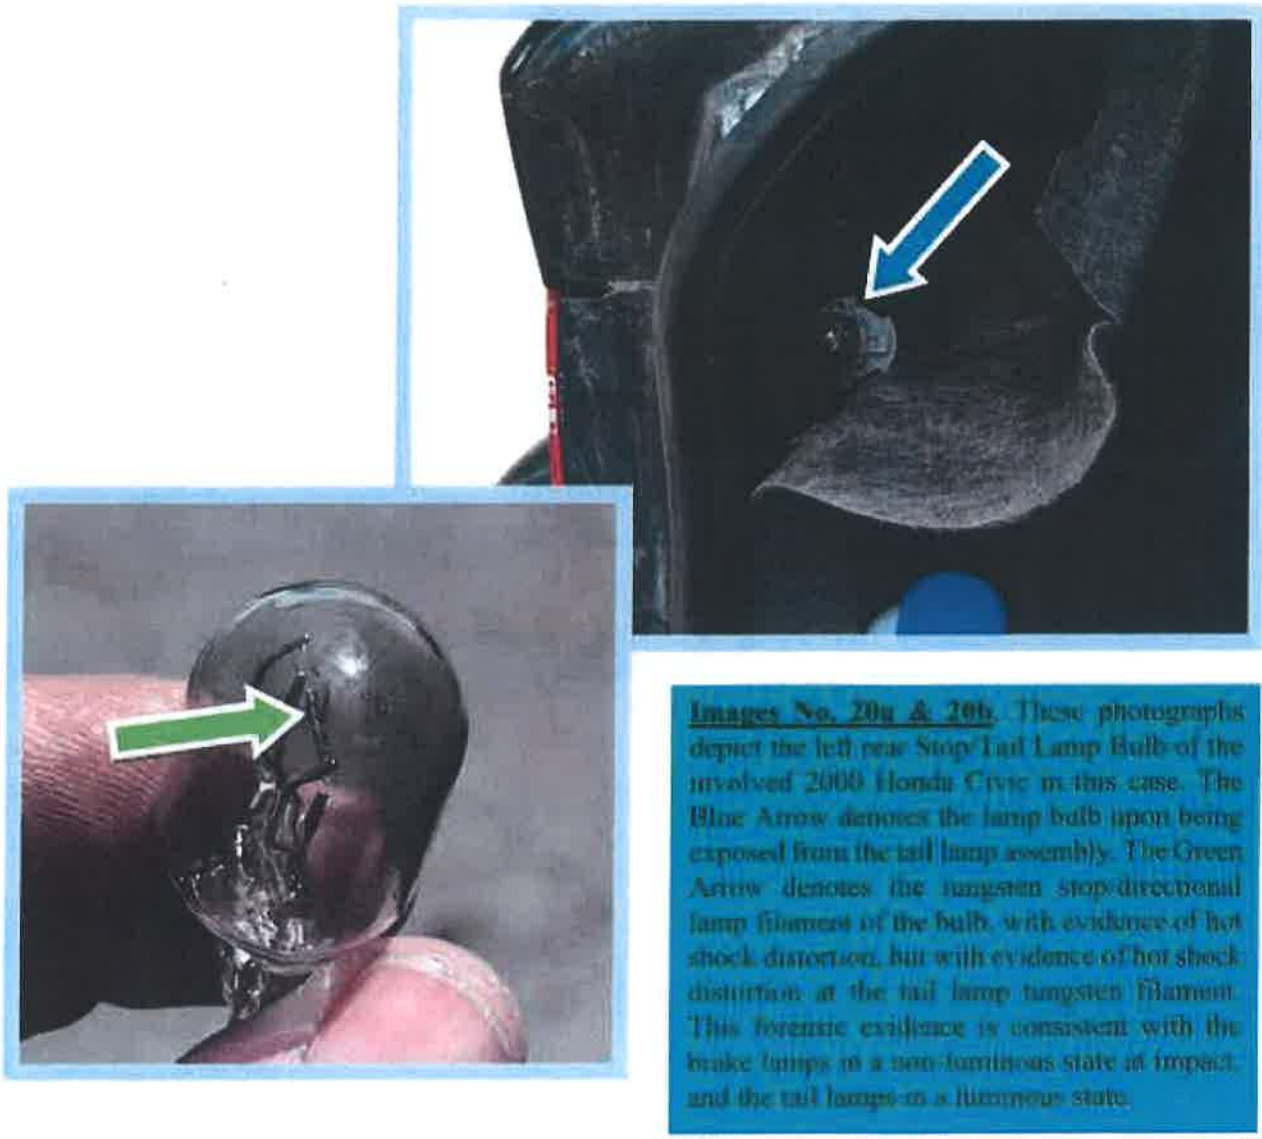
As a segment of the vehicle autopsy of the 2000 Honda Civic EX in this case, the forensic analysis of certain light bulbs of the rear lamp assemblies of the vehicle was performed. This analysis, combined with the previously described analysis of brake system evidence, revealed evidence consistent with no brake application by 2000 Honda Civic operator Edson Thevenin at the time of the violent impact with the concrete barrier of Alternate Route 7 (Collar City Bridge).

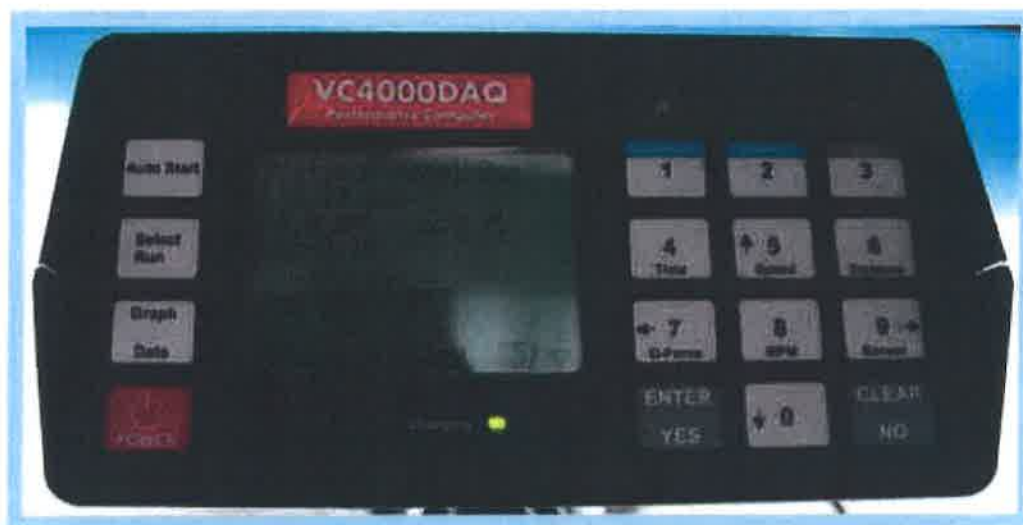
The computer analysis of forward acceleration of the 2000 Honda Civic EX, performed on April 19, 2018 at the Troy Police Department Vehicle Maintenance garage parking lot, revealed that the vehicle accelerated a distance of six (6.0) feet from a stopped position in 2.23 seconds, attaining a speed of 4.8 miles per hour.

Image No. 21 This photograph depicts the Vericom VC4000DAQ computer analysis results of the forward acceleration of the 2000 Honda Civic over a distance of six (6.0) feet from a stopped position.

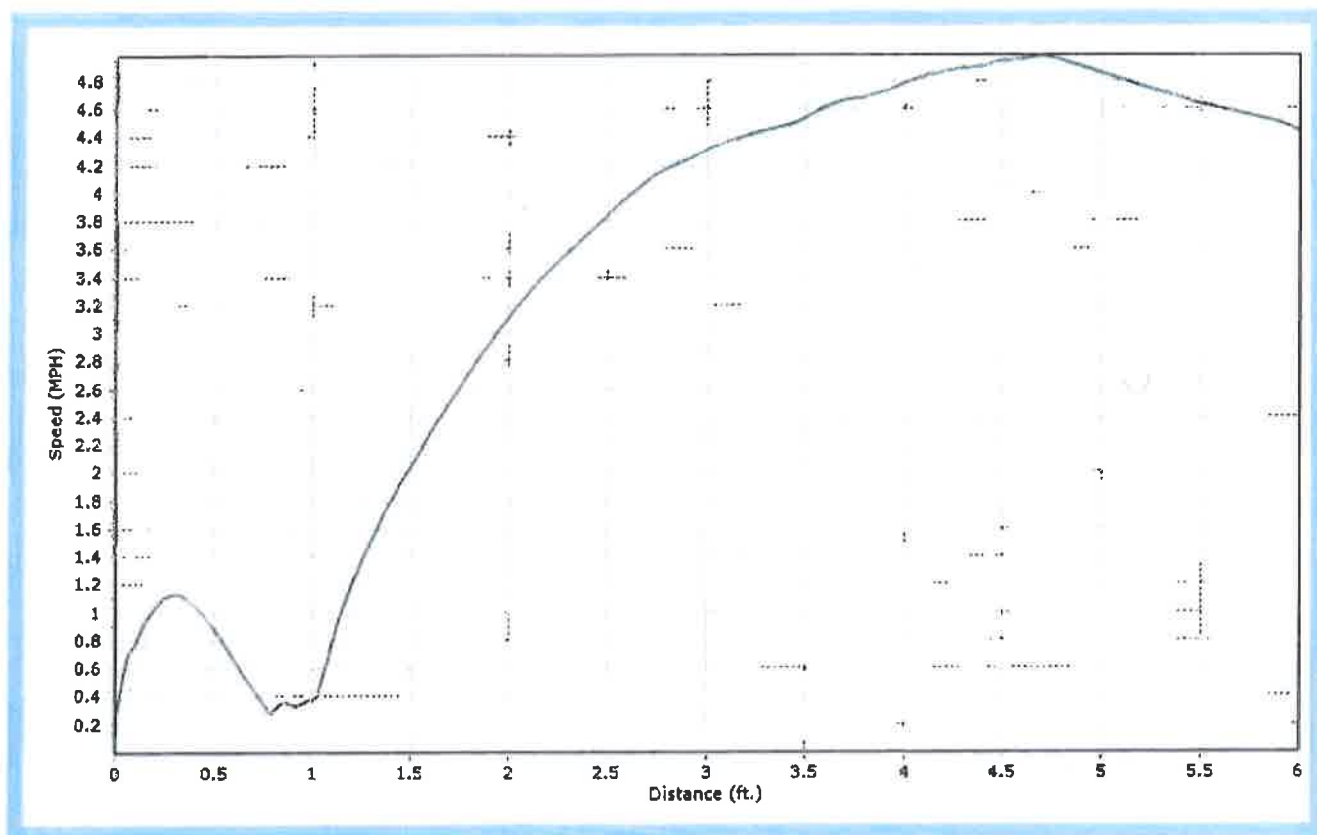
Image No. 22 This graph depicts the Speed of the acceleration of the 2000 Honda Civic in comparison to the Distance of the acceleration of the vehicle. This data and graph were the result of Vericom VC-4000DAQ Computer acceleration analysis

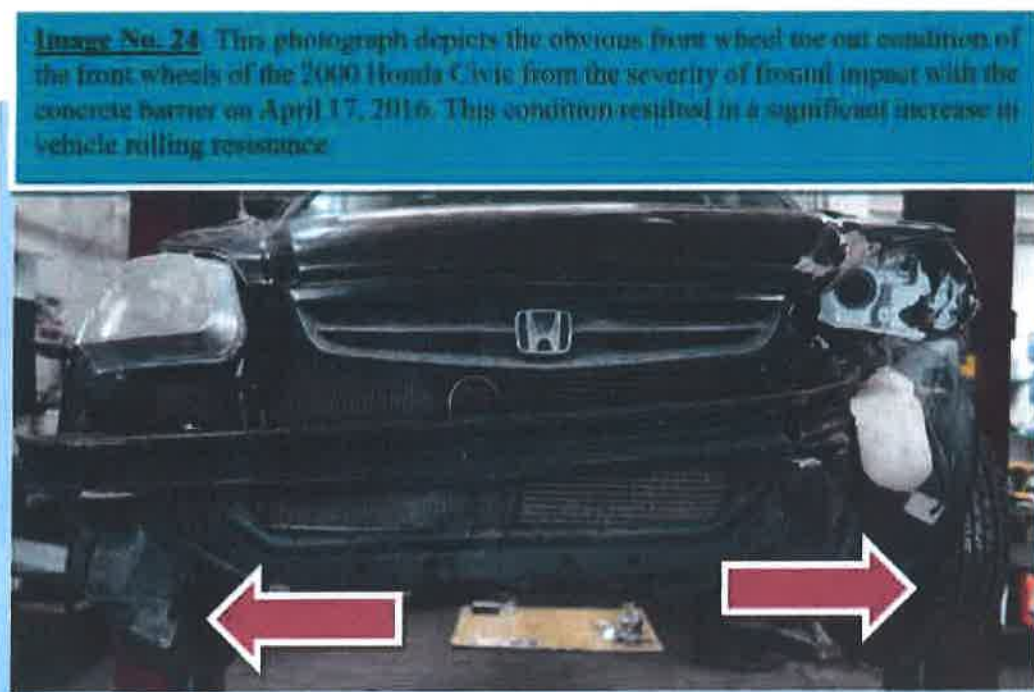
In addition to the readily apparent increased engine RPM required to accelerate the 2000 Honda Civic from a stopped position, perceptible metallic clanging noises emanated from the left front drive axle CV Joints of the vehicle -- also the result of damage due to the severity of vehicular impact with the concrete barrier on April 17, 2016.

The computer acceleration analysis of the 2000 Honda Civic revealed that the maximum acceleration speed for the distance of 39.60 inches was 4.43 miles per hour, and that the minimum time to traverse the distance of 39.60 inches was 1.910 seconds under full acceleration input. Accordingly, the maximum level of Kinetic Energy of the 2000 Honda Civic would have been 1755.7743 ft-lbs⁸.

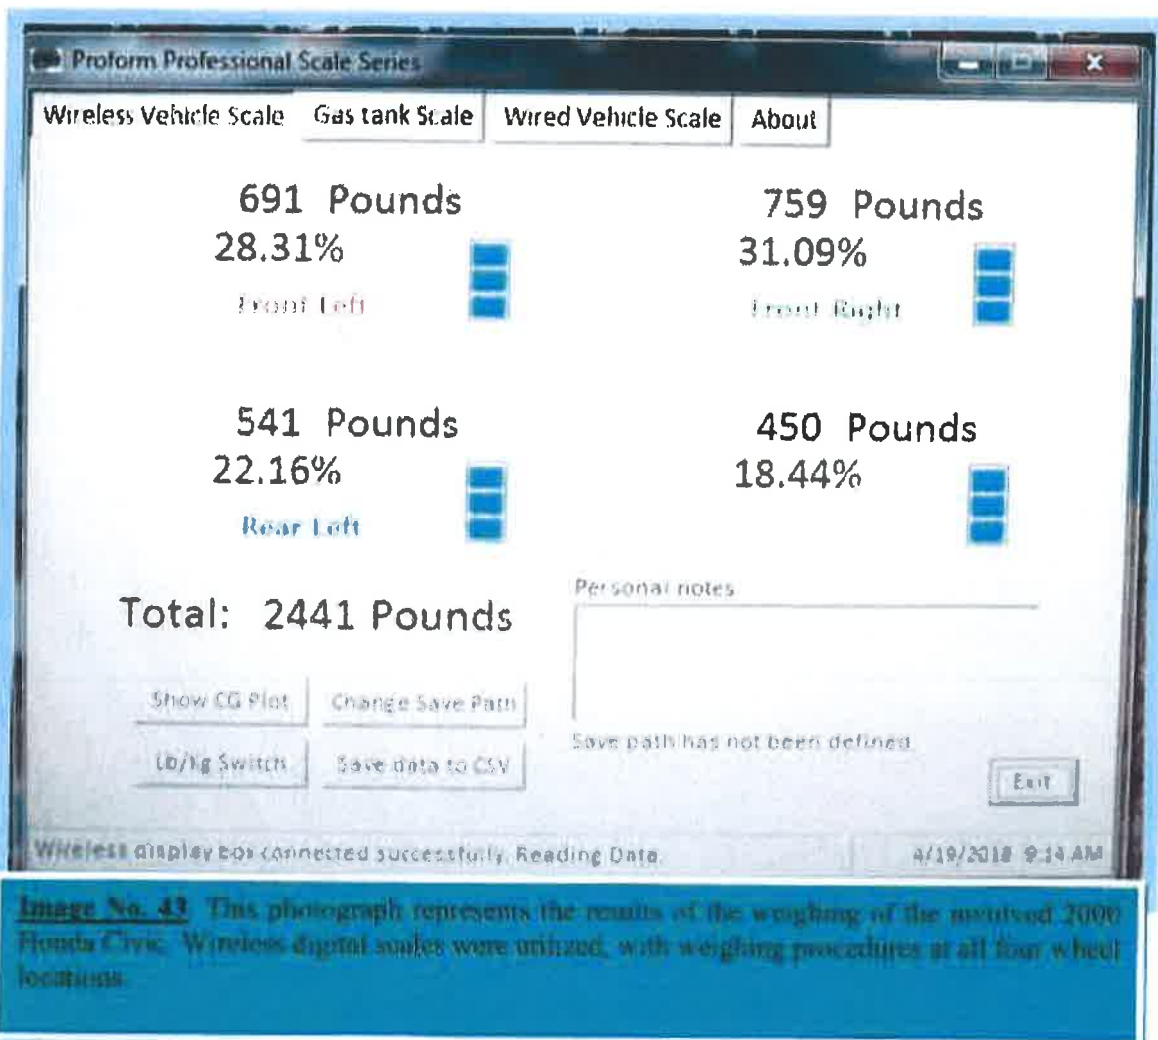
Weight, At Front Right Tire Location (area of fender damage from sideswipe, without operator) = **759 lbs.**

Image No. 43 This photograph represents the results of the weighing of the involved 2000 Honda Civic. Wireless digital scales were utilized, with weighing procedures at all four wheel locations.

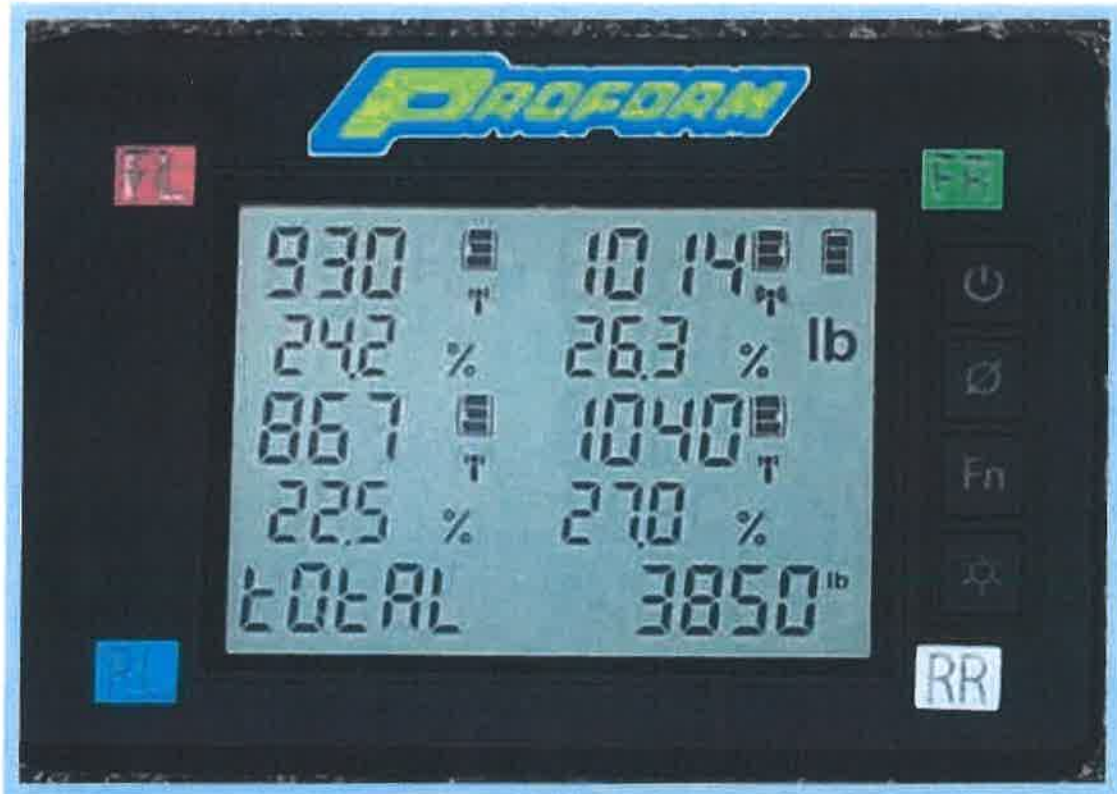
Image No. 44 This photograph represents the results of the weighing of the involved 2013 Ford Taurus. Wireless digital scales were utilized, with weighing procedures at all four wheel locations.

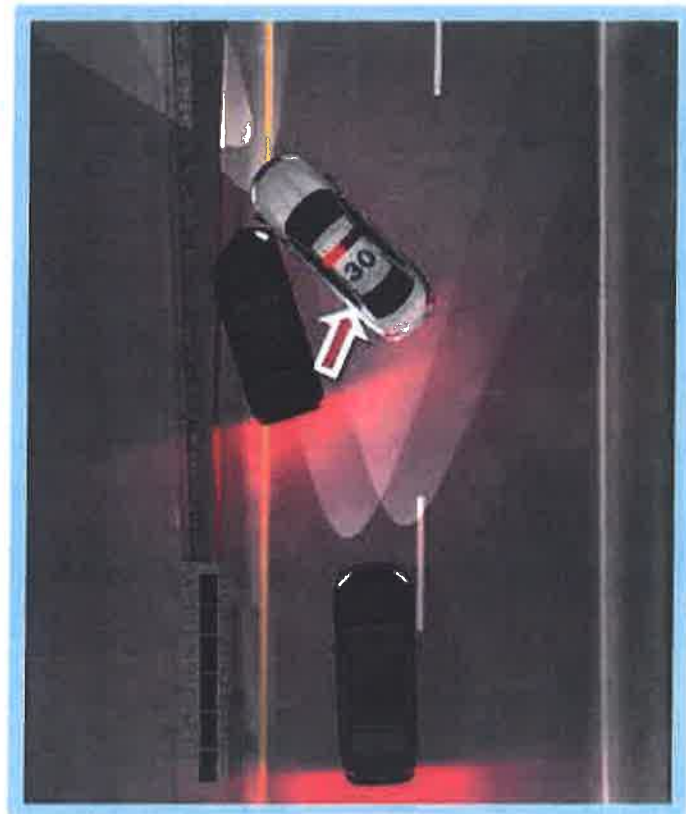
Image No. 45 Based upon physical evidence and forensic scene mapping, this forensic animation still image represents the stopped locations of the involved 2000 Honda Civic and Troy Police Department 2013 Ford Taurus following concrete barrier impact of the 2000 Honda Civic. Given the requisite approach angle of the 2013 Ford Taurus, sideswipe contact with the 2000 Honda Civic is not possible. Additionally, the photographically documented location of the severed right exterior mirror of the Honda (Red Arrow) would not be achievable, as the trajectory of the mirror would be in a direction towards the concrete barrier.

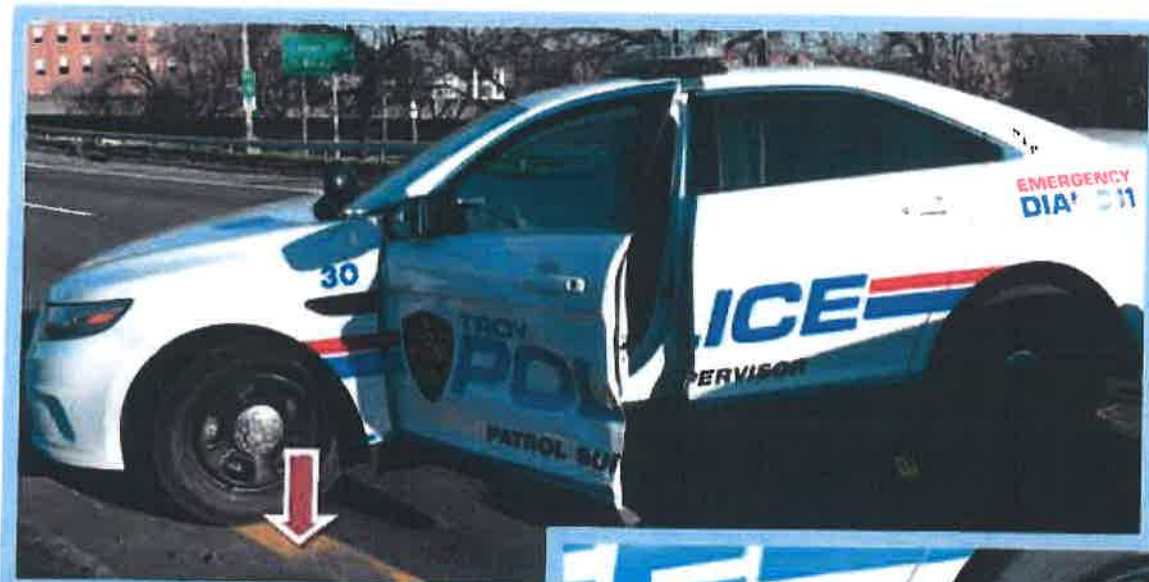
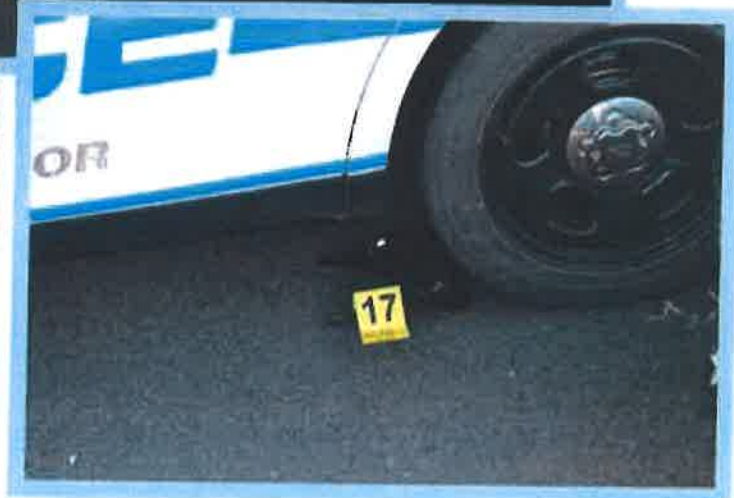
5) The final rest location of the right outside mirror of the 2000 Honda Civic, with physical evidence of forceful severing due to impact by the left front outside door handle of the faster moving 2013 Ford Taurus, is that of a trajectory consistent with the Honda Civic having been impacted in a full sideswipe maneuver as the Honda was operated in a westerly direction on Alternate Route 7 (Collar City Bridge).

Images No. 48a & 48b: These photographs, taken at the scene of the event of April 17, 2018 on Alternate Route 7 (Collar City Bridge) in Troy, New York, depict the final rest location of the severed right exterior mirror of the involved 2000 Honda Civic operated by Edson Thevenin. There was no evidence that the mirror had been impacted by a vehicle tire, thus consistent with the trajectory from impact by the left exterior door handle of the 2013 Ford Taurus. The Red Arrow denotes the previously referenced Honda right front tire scuff mark.

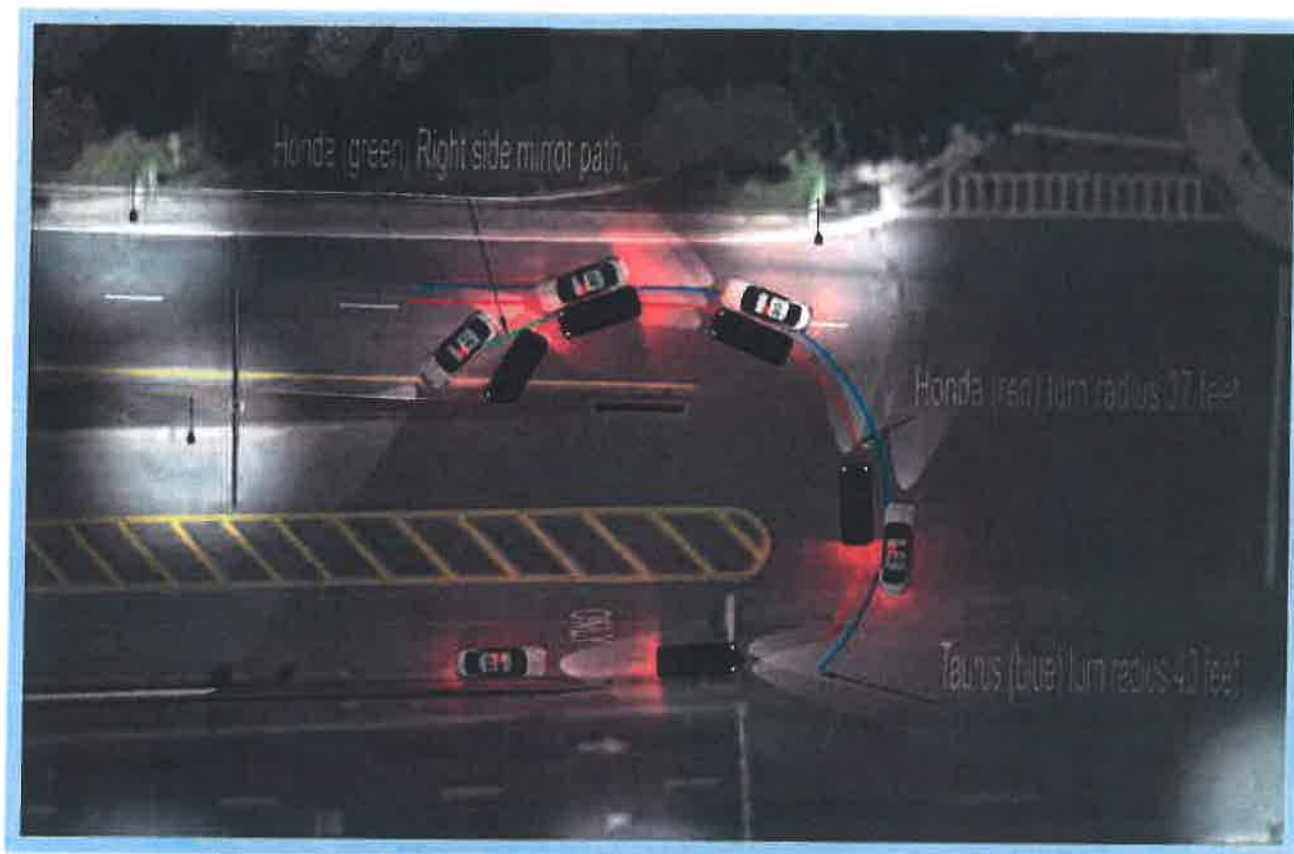
Image No. 49: This 3D Forensic Still Image, created by and through 1) Physical evidence, 2) Scene mapping data, 3) Vehicle turning radius data, 4) Vehicle dimensions, and 5) Forensic science, depicts a scientifically supported scenario with respect to the sideswipe collision of the 2013 Ford Taurus operated by Troy Police Sergeant Randal French and the 2000 Honda Civic operated by Edson Thevenin. (The actual location of impact, vehicle turning radii, and a-turn locations cannot be succinctly established).

Note the trajectory of the right exterior mirror of the 2000 Honda from forceful separation of sideswipe contact to the known location of final rest.

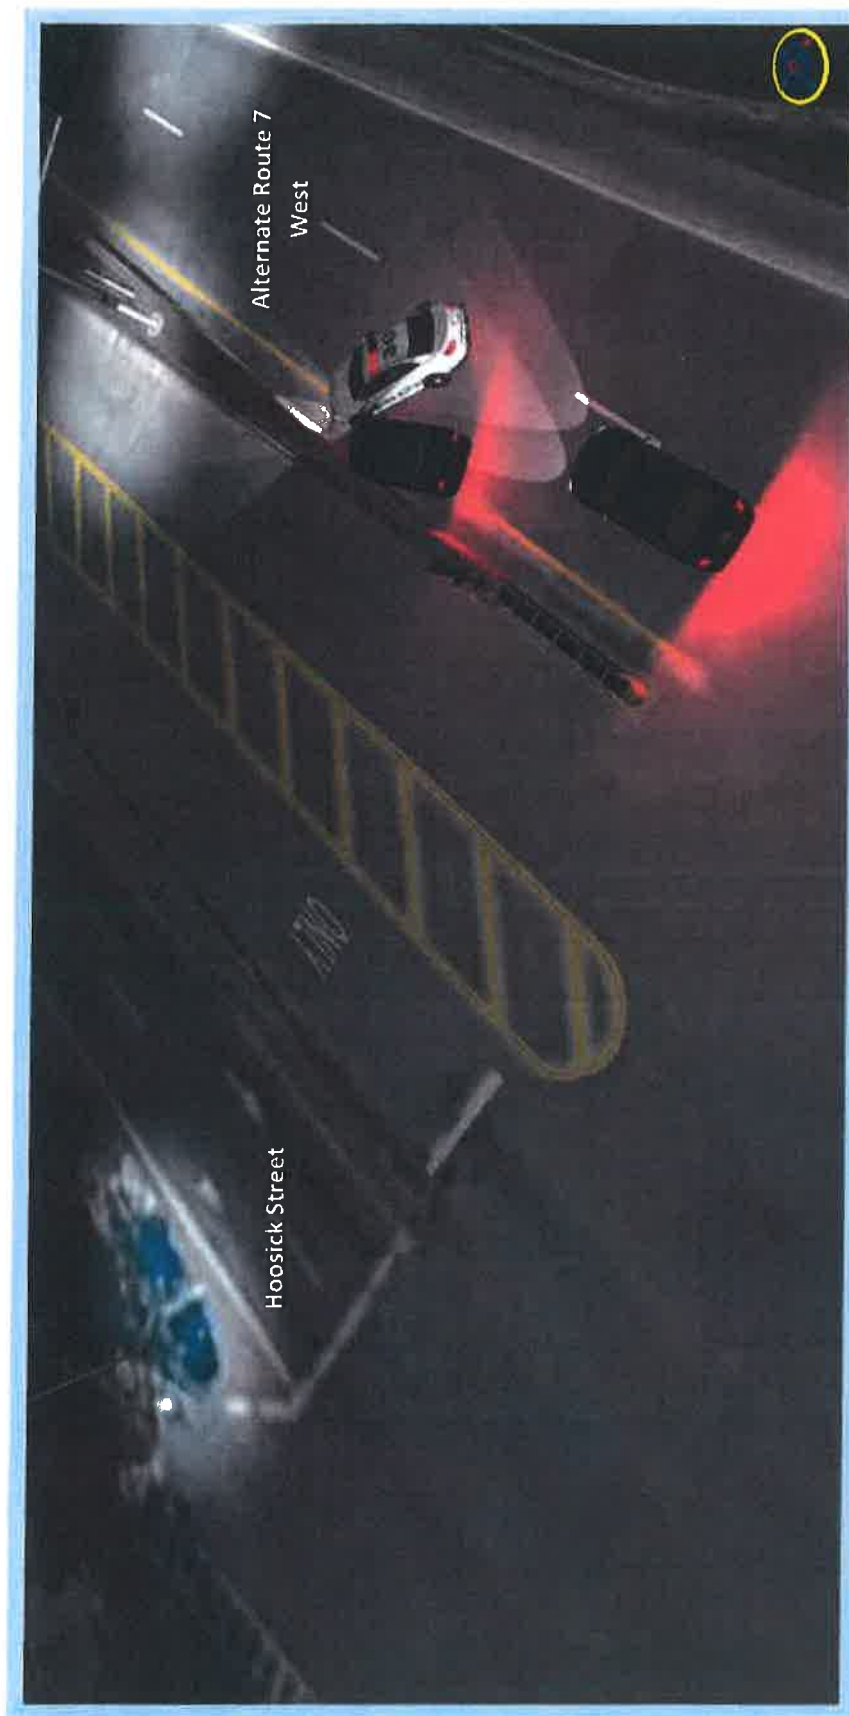
3D Forensic Still Image No. 5, Report Page 8.

Subsequent to the severe concrete barrier impact and resulting clockwise rotation of the 2000 Honda Civic, and with the two Troy Police Department vehicles on scene as depicted by Image No. 5 (above), Honda operator Edson Thevenin purposefully placed the automatic transmission shifter of the vehicle in the REVERSE position and accelerated rearward, ultimately striking the Troy Police Department 2012 Chevrolet Impala operated by Troy Police Captain Matthew Montanino. Analysis of the physical damage of the two motor vehicles reveals that impact occurred between the right rear bumper cover of the 2000 Honda Civic and the left center bumper cover of the 2012 Chevrolet Impala.
